Contract #: 04-0120F4Cty: SF/ALA Rte: 80 PM: 13.2/13.9File #: 69.28**WELDING INSPECTION REPORT****Resident Engineer:**Pursell, Gary**Address:** 333 Burma Road**City:** Oakland, CA 94607**Report No:** WIR-003292**Date Inspected:** 06-Jul-2008**Project Name:** SAS Superstructure**OSM Arrival Time:** 700**Prime Contractor:** American Bridge/Fluor Enterprises, a JV**OSM Departure Time:** 1700**Contractor:** Zhenhua Port Machinery Company, Ltd (ZPMC), Changxing Island **Location:** Shanghai, China**CWI Name:** Sun Wei**CWI Present:** Yes No**Inspected CWI report:** Yes No N/A**Rod Oven in Use:** Yes No N/A**Electrode to specification:** Yes No N/A**Weld Procedures Followed:** Yes No N/A**Qualified Welders:** Yes No N/A**Verified Joint Fit-up:** Yes No N/A**Approved Drawings:** Yes No N/A**Approved WPS:** Yes No N/A**Delayed / Cancelled:** Yes No N/A**Bridge No:** 34-0006**Component:** OBG and Tower**Summary of Items Observed:**

OBG Sub-Assembly Bay 1**Deck Panel Production Welding**

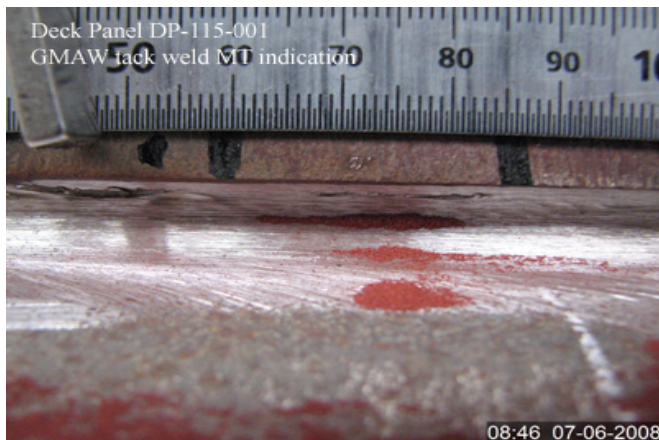
ABF Representative Kit Man Li informed QA that ZPMC performed magnetic particle testing to the tack welds on Deck Panel DP-439-002 and marked 158 out of 250 tack welds for repair and on DP-115-001 5 out of 216 for repair. Below is a digital photograph of a tack weld on DP-439-002 illustrating a typical magnetic particle indication.

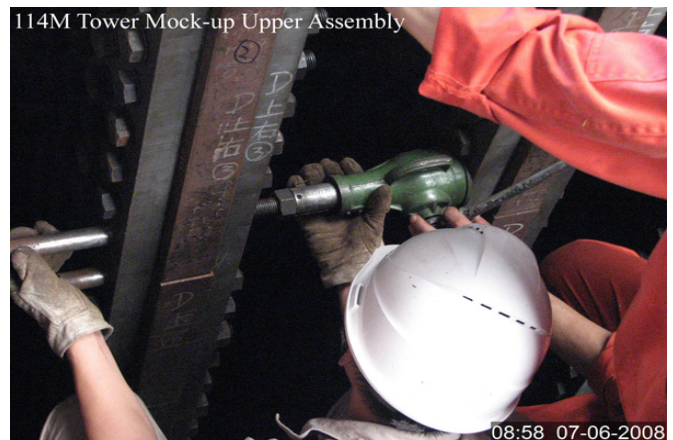
Bay 2 The Quality Assurance Inspector observed ZPMC utilizing a 5 ton jacking device to aid in the

installation of high strength bolts at skin "D" Longitudinal Stiffener Mp1011 between weld numbers 8 and 10. The Quality Assurance Inspector generated a Incident Report pertaining to the discrepancy. Below is a digital photograph illustrating the discrepancy.
